# High Resolution Satellite Imagery for Mapping Invasive Aquatic Plants

Skip Wiegersma and James Ellis

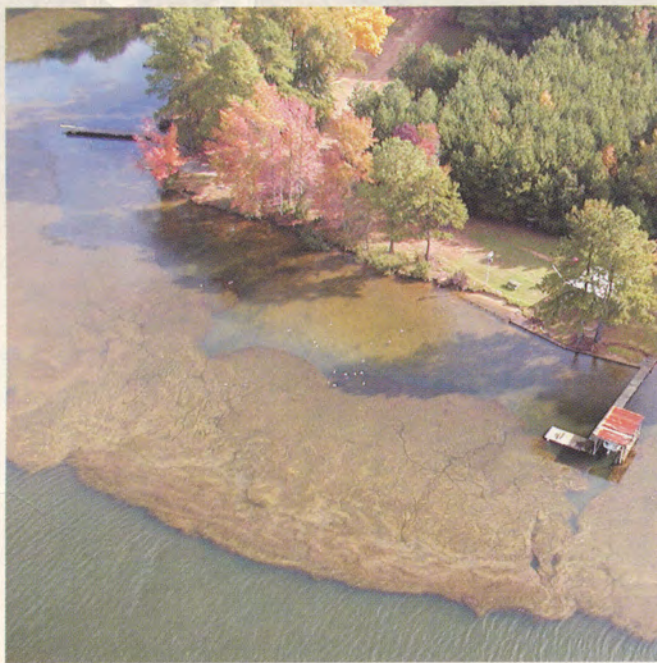
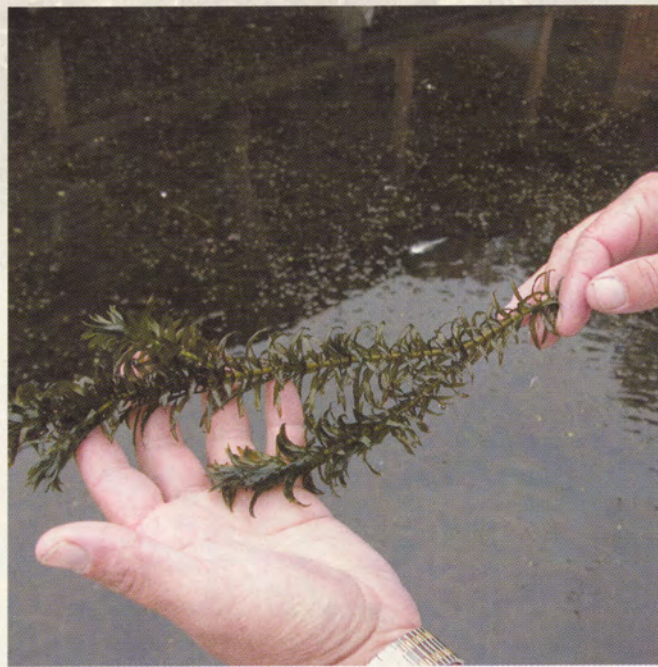
*Figure 1 Invasive aquatic plants cover large areas as seen from a helicopter (left) but do not look very menacing in hand (right).*

Specialty companies have been established who work year-round to limit the impact of these invasive aquatic plants (Figure 1) on our reservoirs and lakes. This case history documents the efforts of a progressive company, Aquatic Nuisance

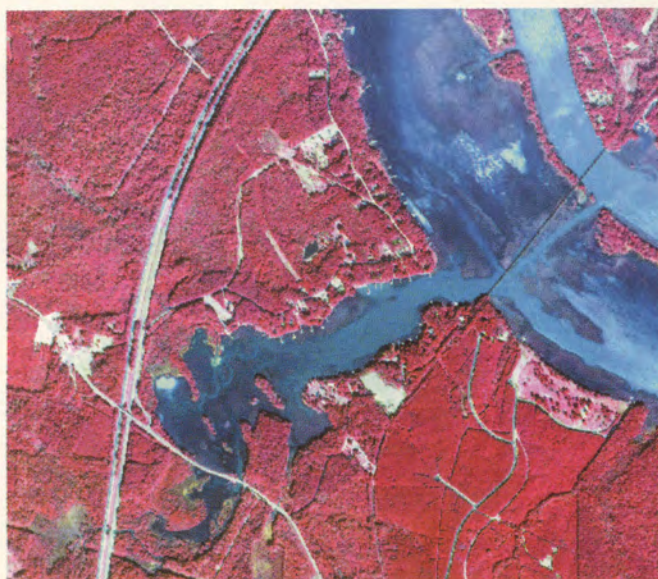
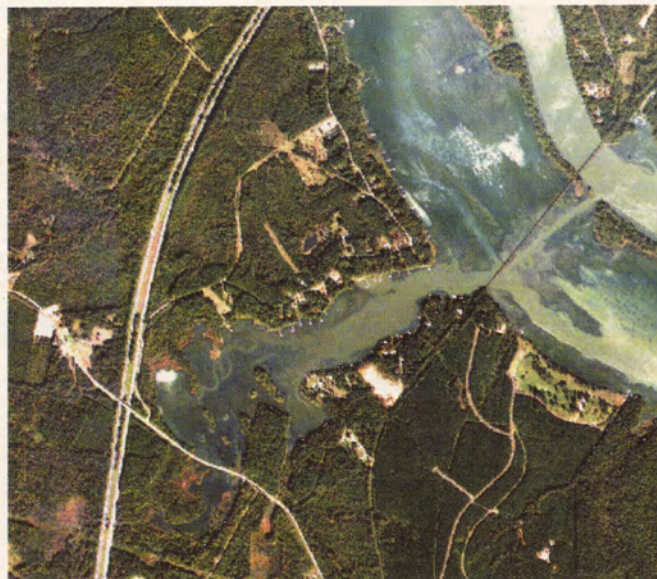
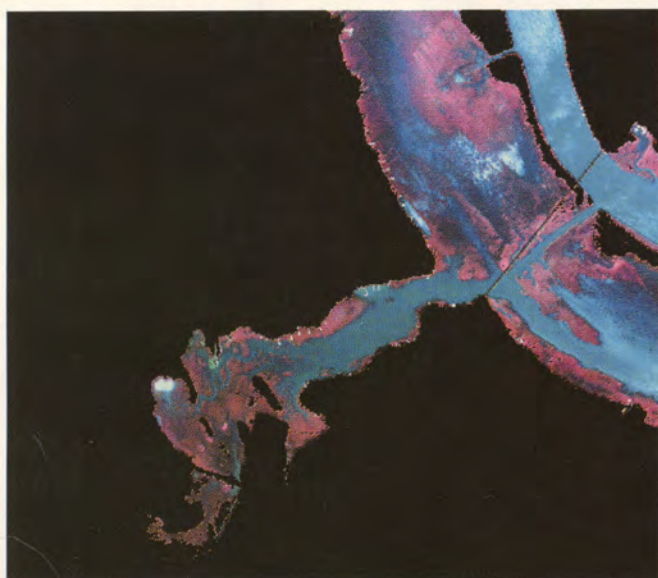
**Figure 3** Western portion of Gaston Reservoir, showing color-infrared image (top left), natural color image (top right), aquatic vegetation (pink, bottom left) highlighted with land mask, and subarea with classification map of land (black), water (blue), masses of Hydrilla (red), and field sites (yellow dots) (bottom right)

Color-infrared composites displayed the onshore vegetation as shades of bright red, while the offshore floating vegetation was displayed as shades of gray. To maximize the visual appearance of the aquatic vegetation on the imagery, a mask was created over the land area, and a color-infrared composite made of only the water in the Gaston Reservoir. This was a highly informative image as the floating vegetation was displayed as shades of pink and was clearly differentiated from the water (**Figure 3**).

shoreline were superimposed on the “ortho-ready” Quickbird imagery in the GIS. The fit between the field sites and imagery was good. Large masses of growing and topped out mixed vegetation were immediately recognized on the enhanced imagery.

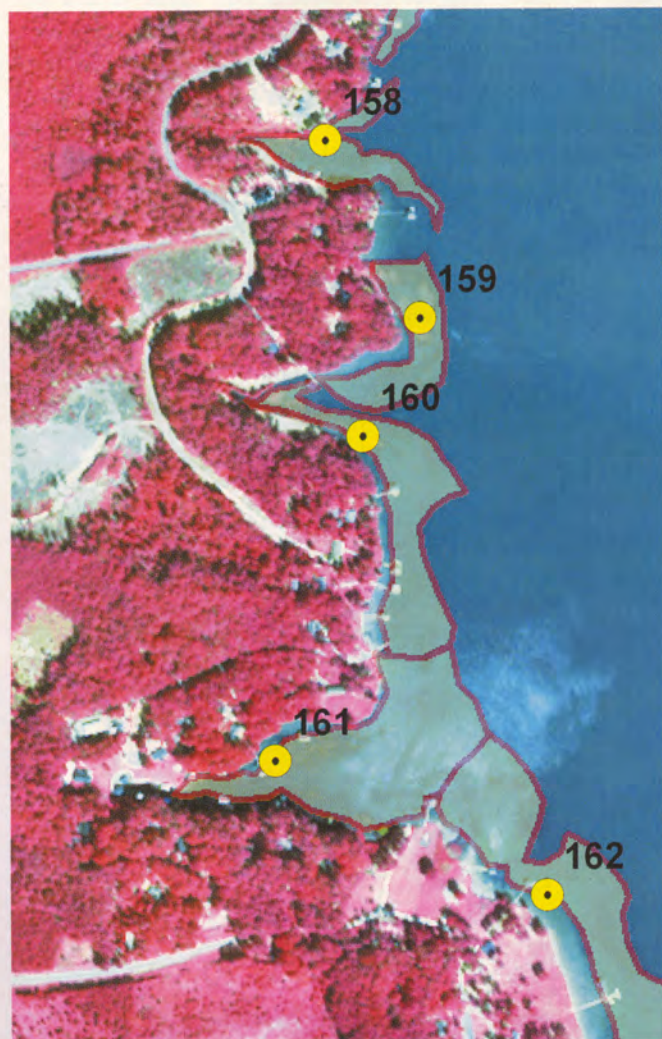
**Figure 4** Masses of Hydrilla interpreted from imagery (polygons along the shoreline) with acreage and location of each plant mass associated with field site

The spectral classification evaluated both supervised and unsupervised methods. It was found that unsupervised classification with 15 classes and three iterations provided good results. The 15 classes were grouped into three—land, water, and aquatic vegetation. These three classes were converted to vector polygons (shapefiles). Statistics were derived from these three classes, including acreage of Hydrilla (**Figure 4**).

field sites were displayed in the GIS and the attributes posted on the screen during interpretation. As the polygons were being mapped, they were assigned to specific field sites. This correlation has significant advantages as acreage of Hydrilla and other vegetation was immediately assigned to each field site. The new attribute table being developed with heads-up interpretation was joined in the GIS to the extensive attributes documented in the field for each site.

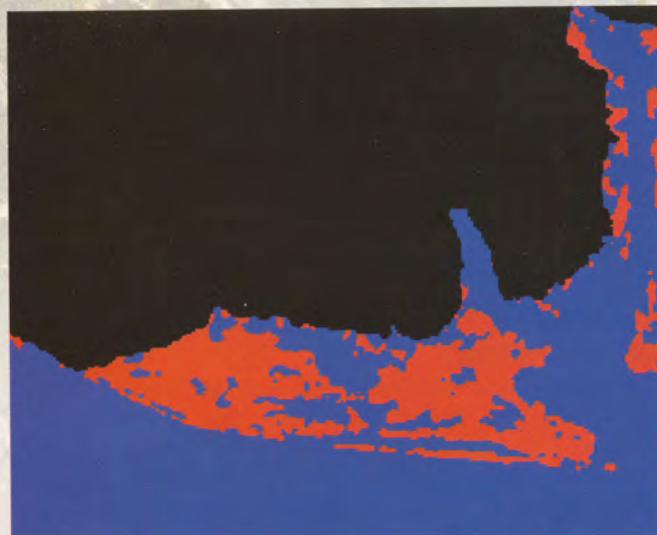
**Figure 5** Close-up of developed area with docks built into water shown as white and masses of Hydrilla (red in classification map)
